# FIELD REPORT

<b>Date</b> 2-29-2024	<b>Project Name</b> North Kitsap United	<b>Project No.</b> 20230246H002	<b>Report No.</b> 2024-01
<b>Location</b> South Port Gamble	<b>Municipality</b> Kitsap County	<b>AESI Project Manager</b> Matt Miller, PE	<b>AESI Field Rep</b> Dustin Williams
<b>Permit No.</b>	<b>Client/Owner</b> Raydient	<b>Attn</b> Jon Rose	<b>Requested By</b> Client
<b>Engineer/Architect</b> DEA	<b>General Contractor</b>	<b>Grading Contractor</b> Seton Construction Inc.	<b>Weather</b> Overcast/Rainy

**EXISTING SITE AND  
EXPLORATION PLAN**  
 NORTH KITSAP UNITED  
 KITSAP COUNTY, WASHINGTON

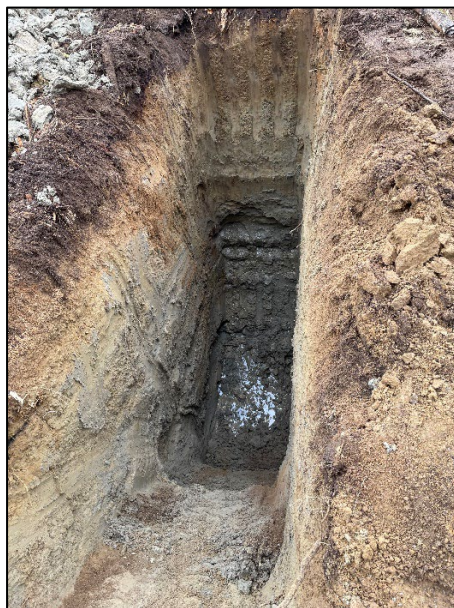
Exploration pit EP-15 was located at the base of hummocky hill, north of the main access road. EP-15 was excavated to a total depth of 12.0 feet below ground surface. The excavation encountered Quaternary colluvium near the surface and Pre-Fraser fine grained sediments at approximately 8.0 feet below ground surface. The general characteristic of the sediments observed were fine sands interbedded with silt. Groundwater seeps were observed emanating from sand beds between depths of 8.0 to 9.0 and 10.5 to 11.5 feet below ground surface (bgs) at an estimated flow rate of less than one gallon a minute. Heavy caving was observed between 9.0 to 11.5 due to running sands at the location of groundwater seeps. Once the pit was backfilled, we attempted to drive a well point approximately 15 feet northwest of EP-15. Well point installation was unsuccessful as the steel casing bent while attempting to drive the well point into stiff silt.

Groundwater is interpreted to be present at depth in the Vashon recessional outwash at the contact with the pre-Fraser fine-grained sediments.

Photograph 1: Exploration pit EP-15 with groundwater seeps between depths of 8.0 to 9.0 and 10.5 to 11.5 feet bgs.

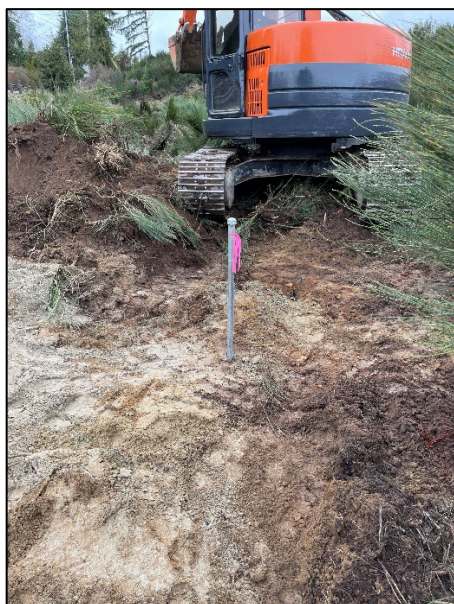
EP-18 and WP-2 were located downslope from EP-15, near the center of the low area. Exploration pit EP-18 was excavated to a total depth of 12.2 feet below ground surface. The excavation encountered Vashon recessional outwash for the full depth explored. The general characteristics of the recessional sediments observed were fine sands with intermittent discontinuous sandy silt lenses. No groundwater seeps were observed. No caving was observed. Once the pit was backfilled, a drive well point (WP-2) was installed approximately 15 feet northwest of EP-18. Well point WP-2 was driven to a total depth of 9.9 feet below ground surface.

Photograph 2: Well point WP-2 located approximately 15 feet northwest of exploration pit EP-18.

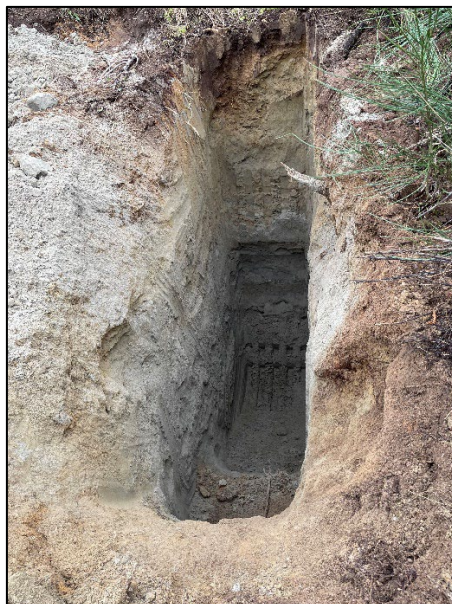
Exploration pit EP-16 was located in the low area south of the main access road. EP-16 was excavated to a total depth of 12.8 feet below ground surface. The excavation encountered Vashon recessional outwash near the surface to nearly the total depth. We interpret that Pre-Fraser fine grained sediments were present at approximately 12.5 feet below ground surface, however only a few inches of harder silt were encountered at the maximum reach of the excavator. The general characteristics of the recessional sediments observed were fine sands with intermittent discontinuous thin sandy silt lenses; the limited exposure of Pre-Fraser sediments observed were silt. No groundwater seeps were observed. No caving was observed. Once the pit was backfilled, a drive well point (WP-1) was installed approximately 15 feet northwest of EP-16. Well point WP-1 was driven to a total depth of 9.9 feet below ground surface.

Photograph 3: Exploration pit EP-16 with Vashon recessional outwash fine sand and no groundwater seeps.
