# CRITICAL AREAS RECONNAISSANCE AND WET WEATHER REVIEW

**NK United**  
*Kingston, Washington*

Prepared for  
**Raydient LLC**  
**19950 7th Avenue NE**  
**Suite #200**  
**Poulsbo, WA 98370**  
**(360) 697-6626**

*Prepared by*  
**Ecological Land Services, Inc.**  
1157 3rd Avenue, Suite 220A • Longview, WA 98632  
(360) 578-1371 • Project Number 3638.05

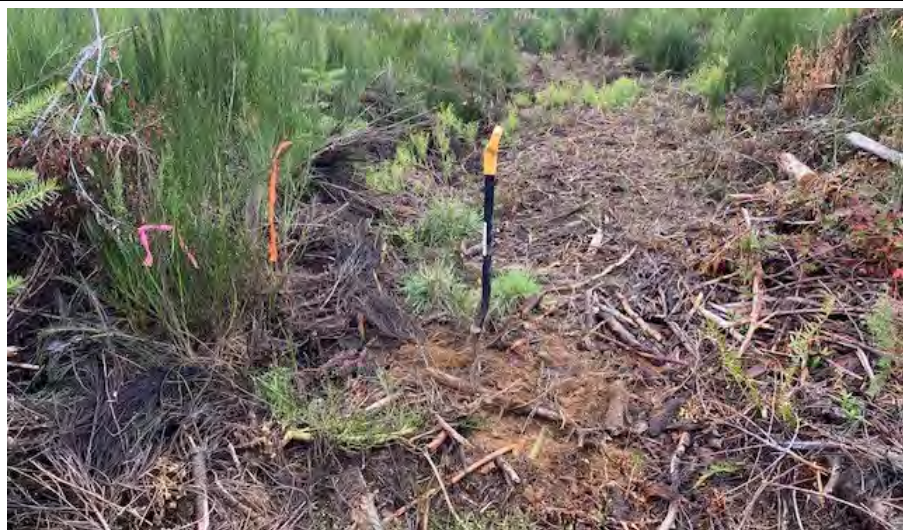
**Photo 1**-Test Plot 3 within the lower end of mapped stream in South Segment. No stream channel this location.

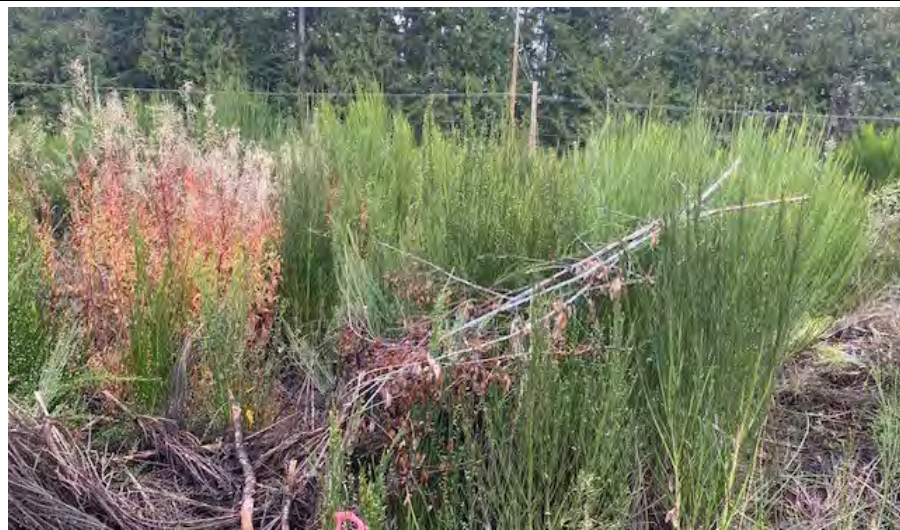
**Photo 2**-Test Plot 3 looking east toward Bond Road/SR 307 along the mapped stream.

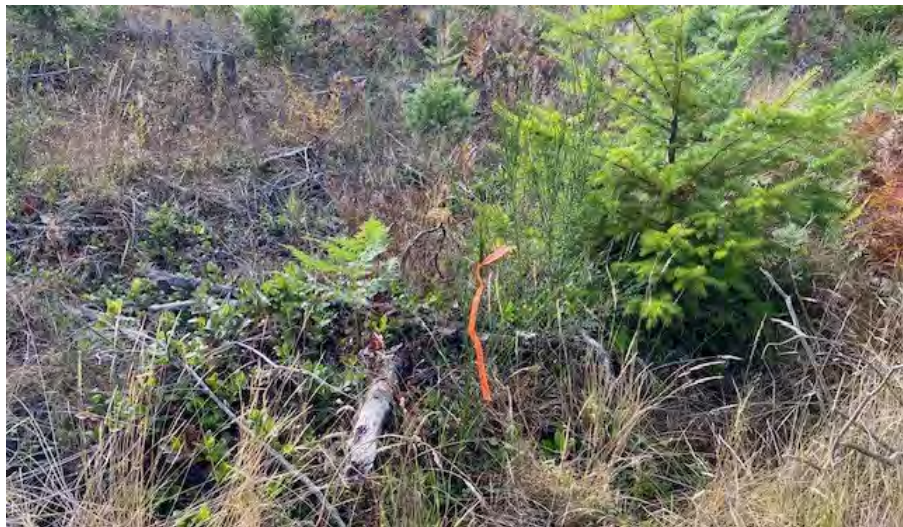
**Photo 3**-Test Plot 8 in the middle segment of the mapped stream within the South Segment. Upland vegetation and no stream channel.

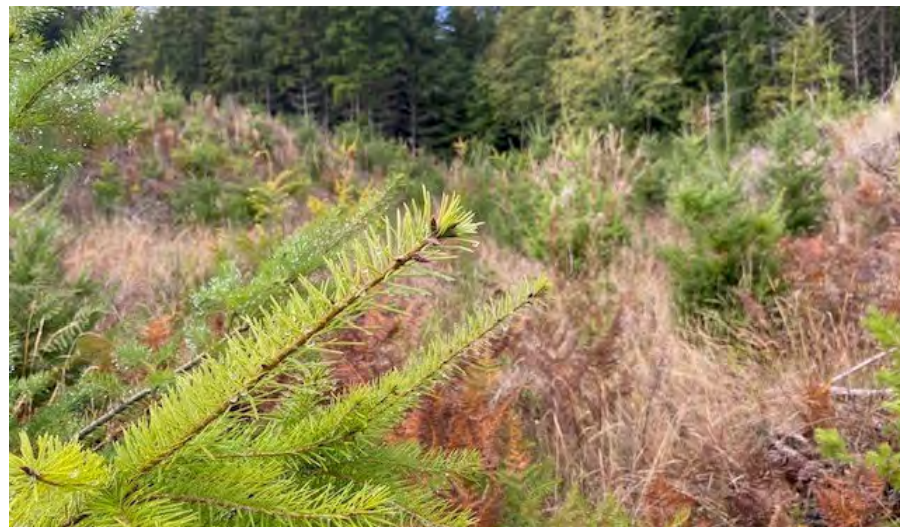
**Photo 4**-Test Plot 8 looking upslope and west along the mapped stream. No stream channel and presence of upland vegetation.

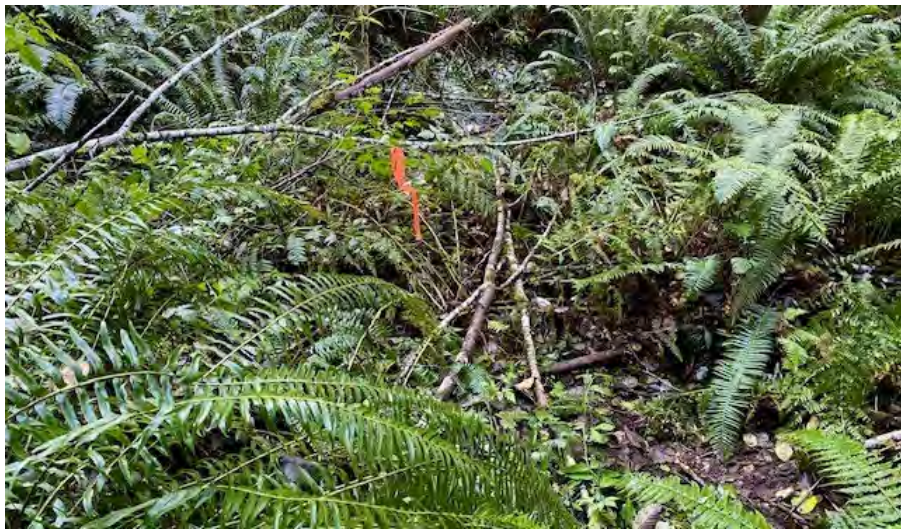
**Photo 5**-Test Plot 11 conducted in southernmost mapped stream in South Segment. No stream observed.

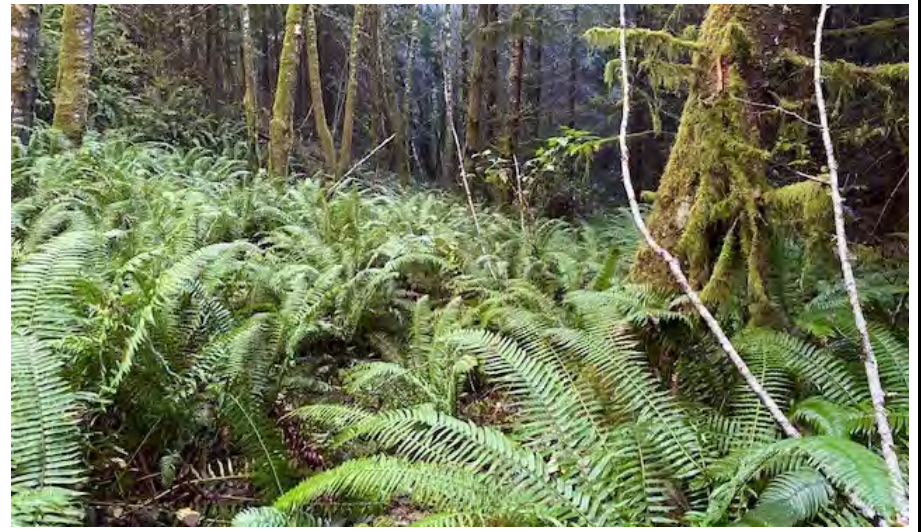
**Photo 6**-Test Plot 11 looking east down the ravine in which the stream is mapped. Dense ferns throughout and no channel observed.

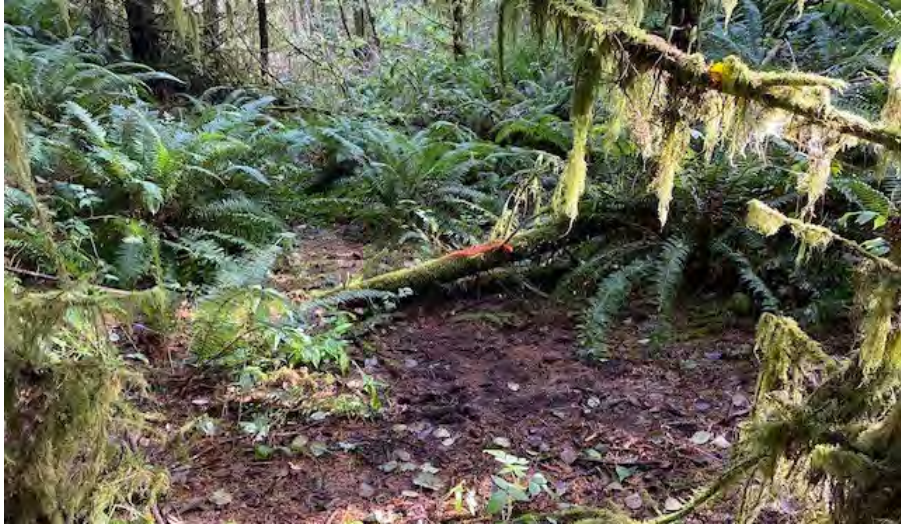
**Photo 7**-Test Plot 18 located at the western extent of the onsite stream in South Segment. Bare ground but no channel observed.

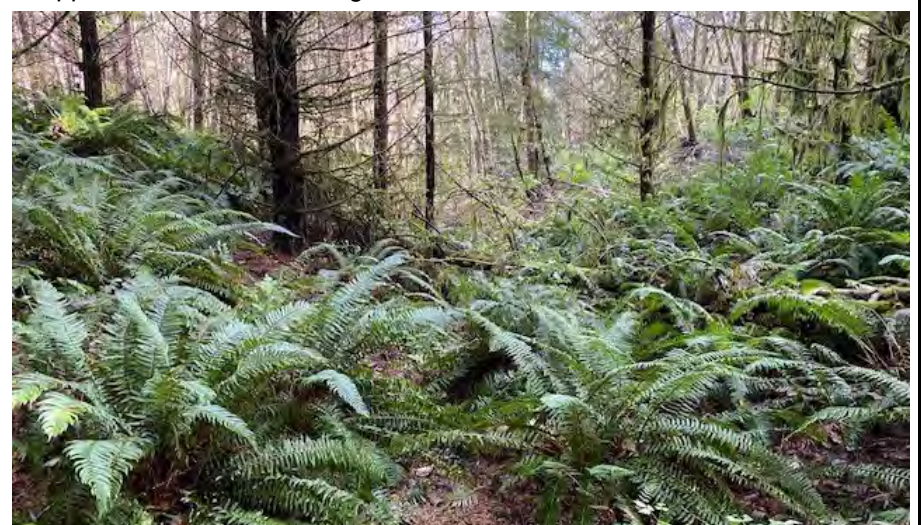
**Photo 8**-Test Plot 18 looking east down the sloping ravine. No stream channel or evidence of water flow.

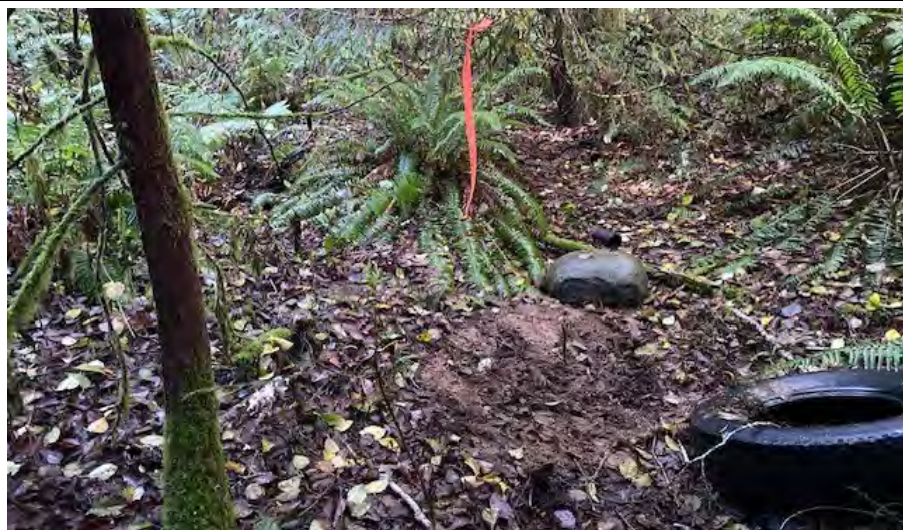
**Photo 9**-Test Plot 20 conducted at the east end of a ravine parallel to Stottlemeyer Road. Not mapped as a stream and none observed.

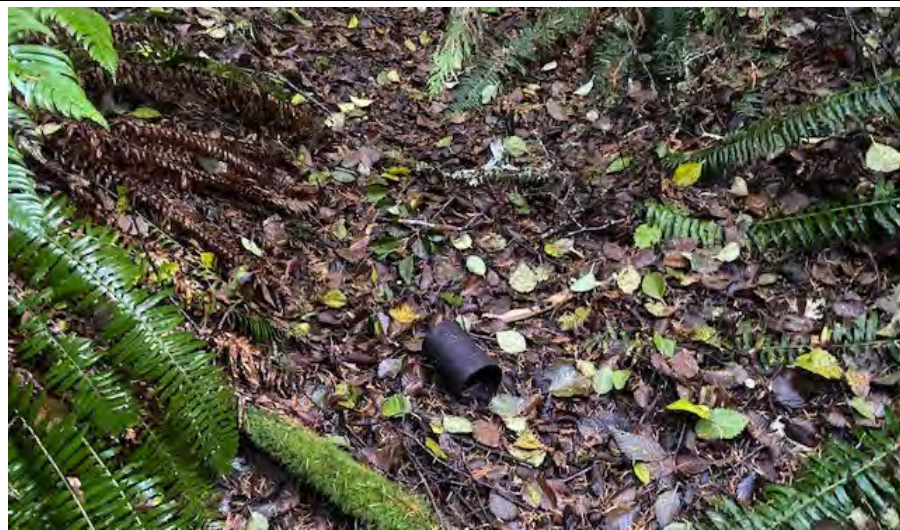
**Photo 10**-Test Plot 20 looking north toward culvert under Stottlemeyer Road. Bare ground with no evidence of water flow.

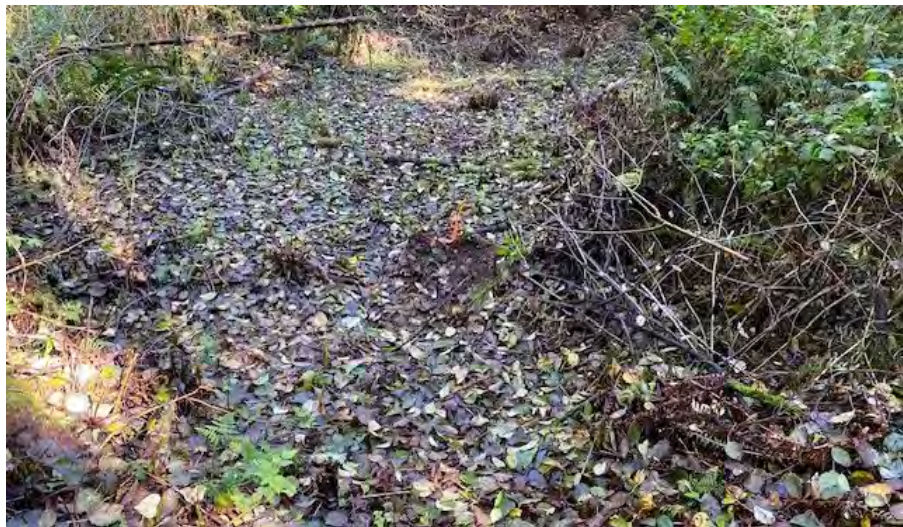
**Photo 11**-Test Plot 21 (east of Stottlemeyer Road) in the southernmost stream in South Segment. Along path cleared for easy access.

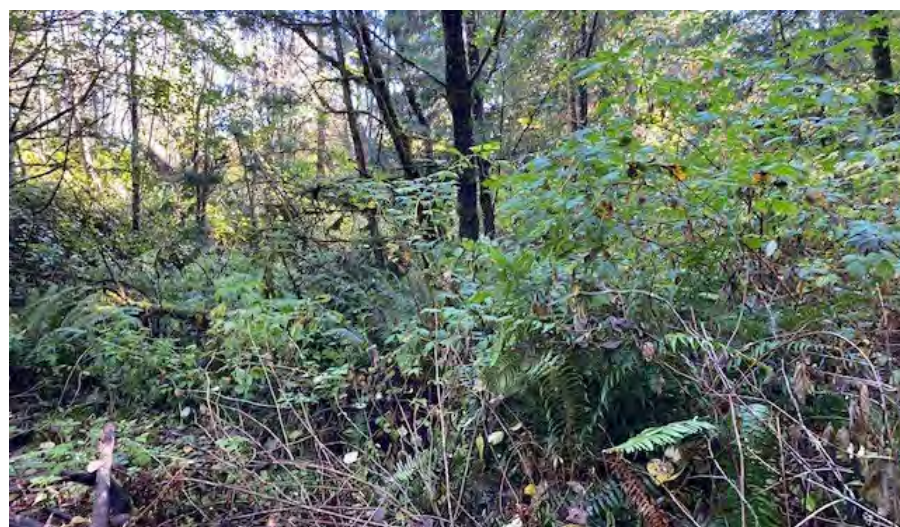
**Photo 12**-Test Plot 21 looking east toward Bond Road (SR 307). Dense vegetation with no channel observed within the mapped area.

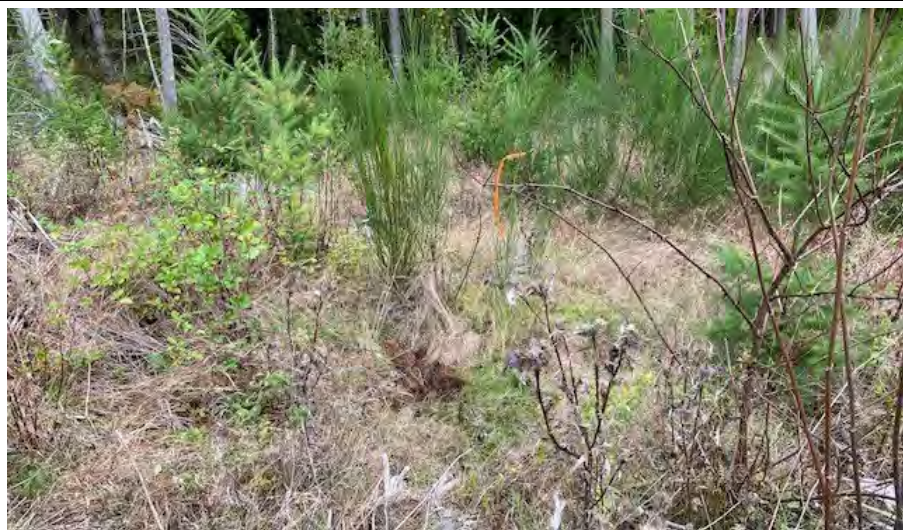
**Photo 13-**Test Plot 35 in the mapped stream at northern edge of harvested forest within the Central Segment.

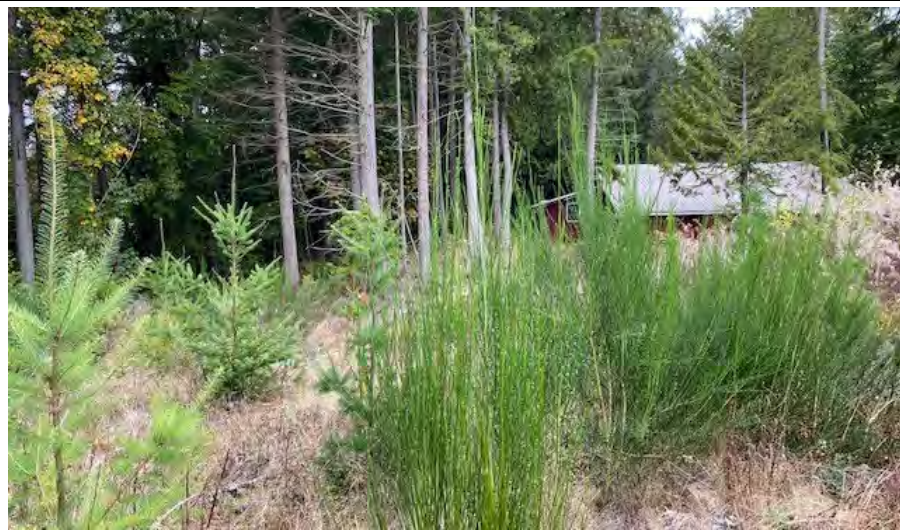
**Photo 14-**Test Plot 35 looking downslope and easterly along mapped stream.

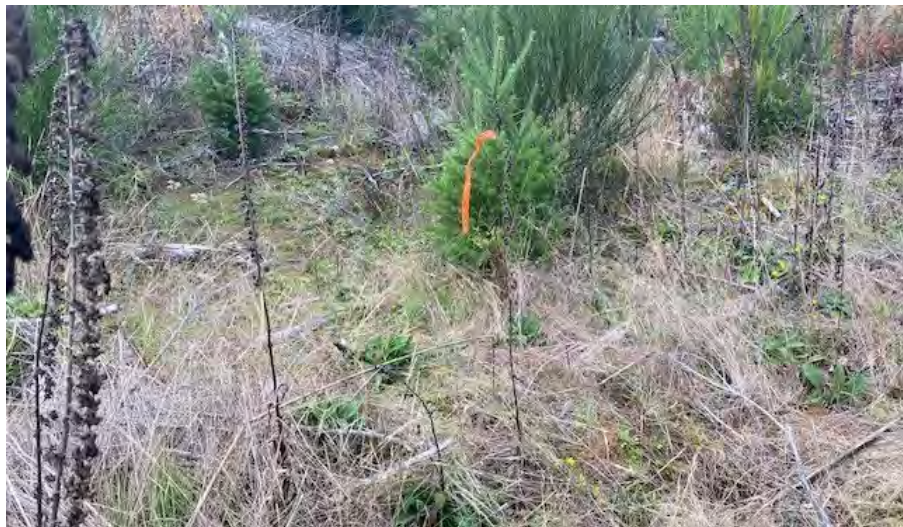
**Photo 15-**Test Plot 38 in topographic trough where stream is mapped. No channel observed and no evidence of water flow.

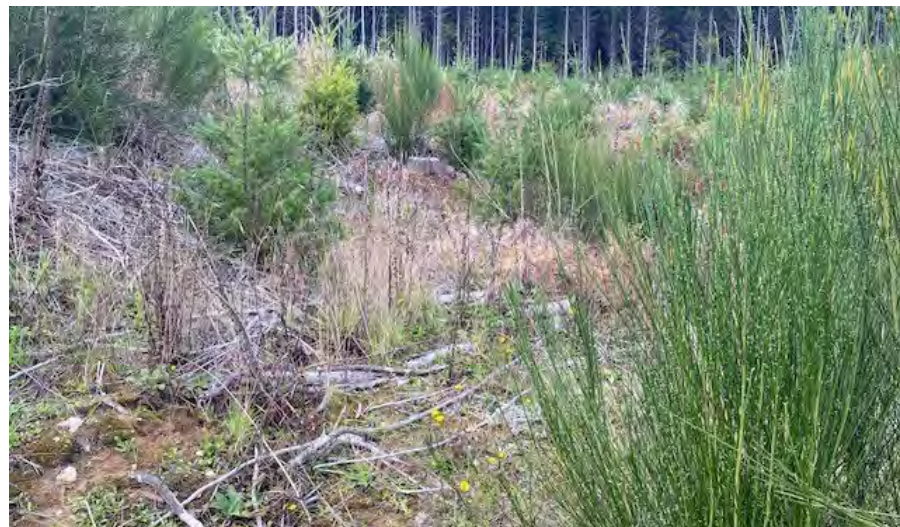
**Photo 16-**Test Plot 38 looking southeasterly down the topographic trough. No stream channel or evidence of water flow.

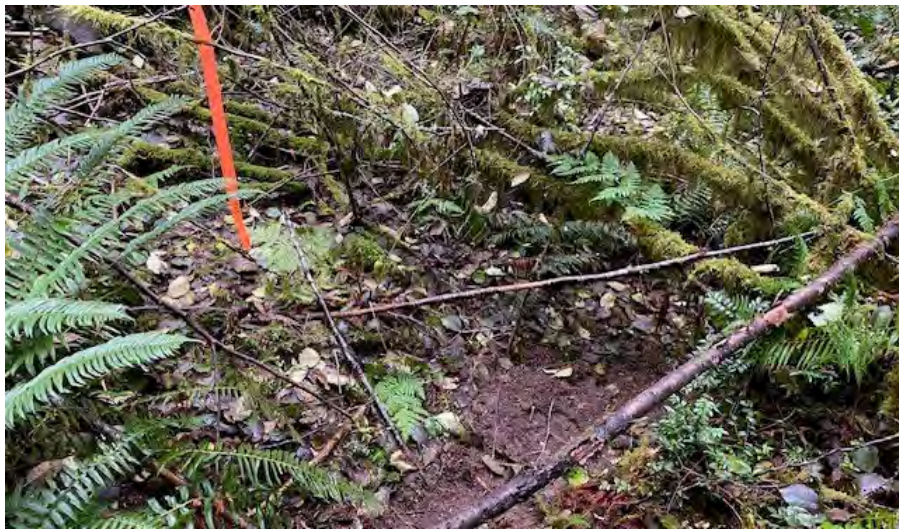
**Photo 17**-Test Plot 30 located within a ravine where a stream has not been mapped. No stream or evidence of water flow observed.

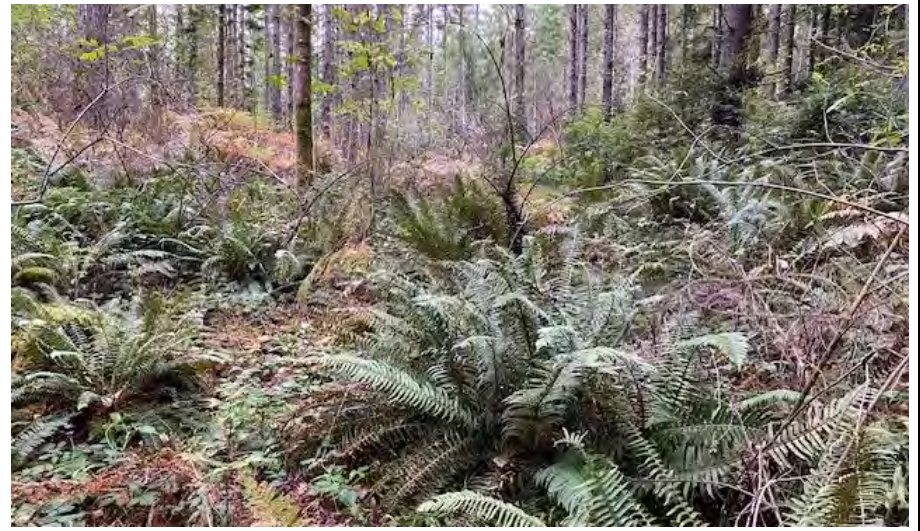
**Photo 18**-Test Plot 30 looking downslope and easterly within the topographic trough.

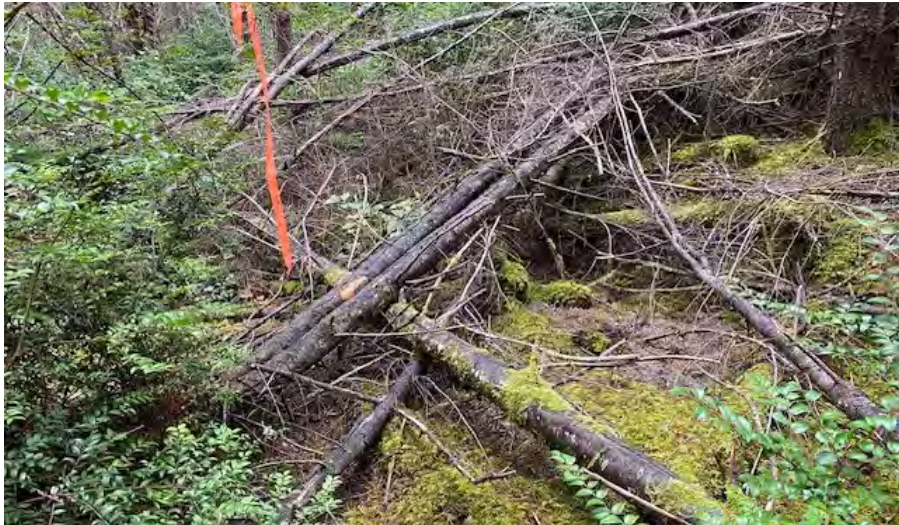
**Photo 19**-Test Plot 44 in topographic trough with no mapped stream. Downslope of a large slash pile within the trough.

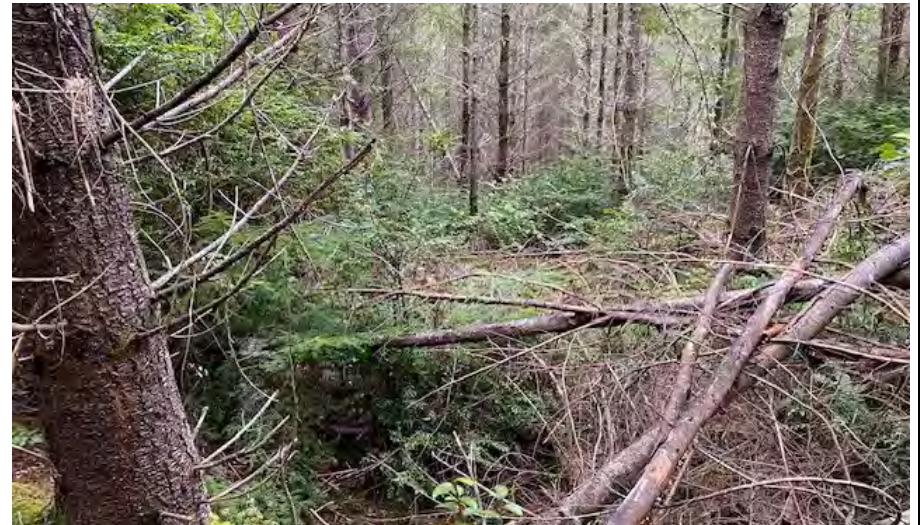
**Photo 20**-Test Plot 44 looking downslope and north into trough. No stream or water flow indicators present.

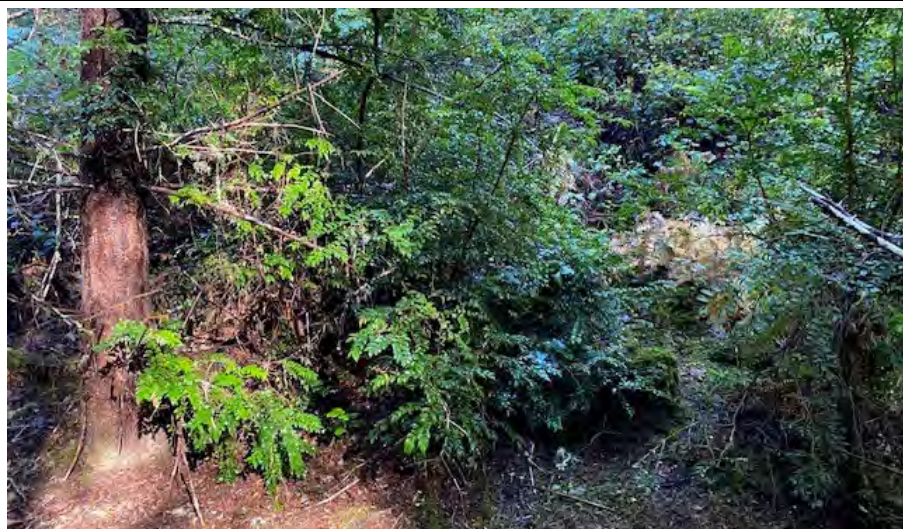
**Photo 21**-Photo Point 5 looking east to document site conditions. A stream was not observed within this area.

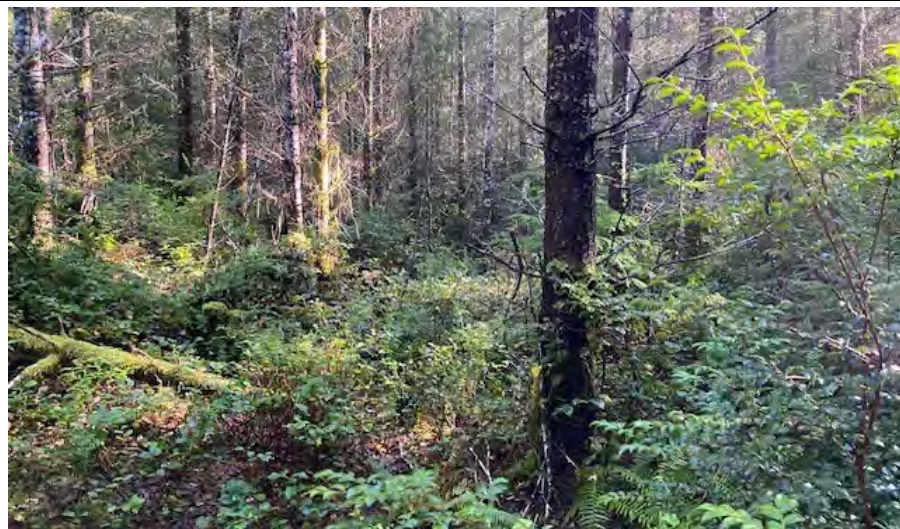
**Photo 22** Photo Point 5 south looking downslope where there is dense vegetation cover not indicative of stream conditions.

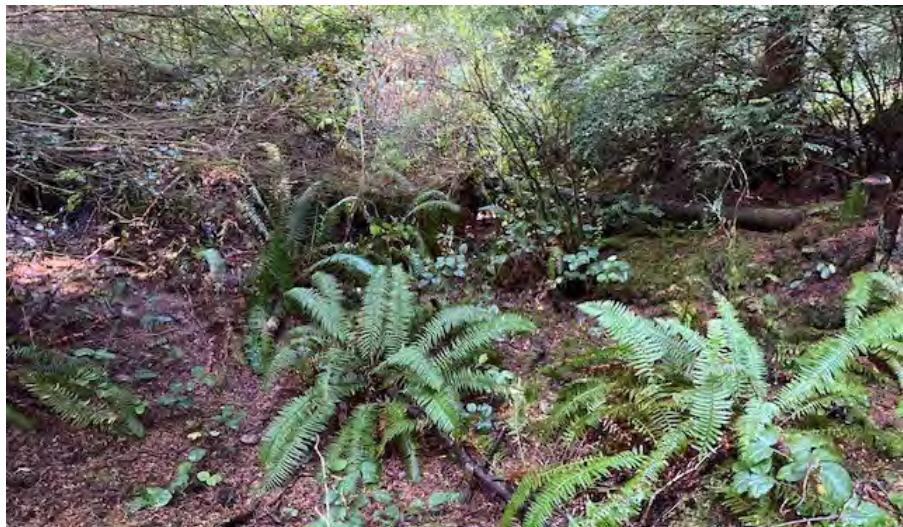
**Photo 23**-Photo Point 10 is located along a topographic trough that lies west of Stottlemeyer Road. Non mapped stream/no stream.

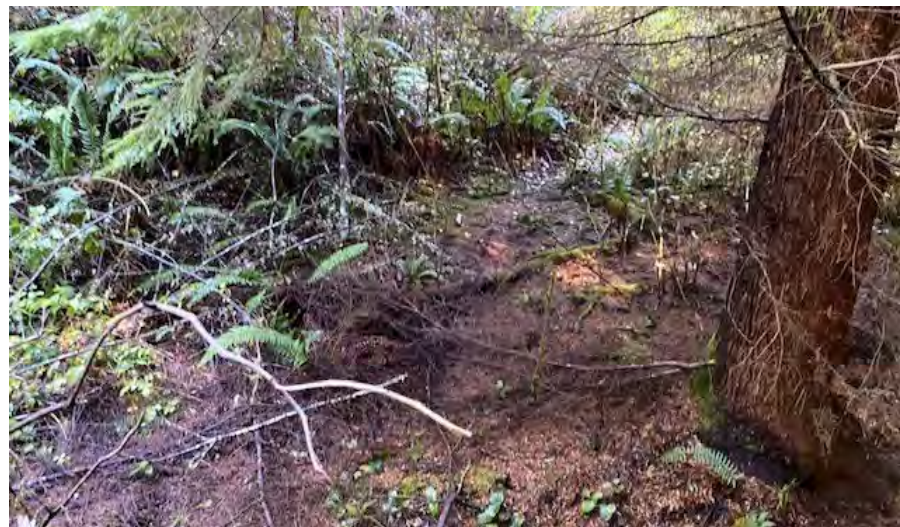
**Photo 24**-Photo Point 10 west shows another area of the topographic trough where no stream was observed during the 10/23 site visits.

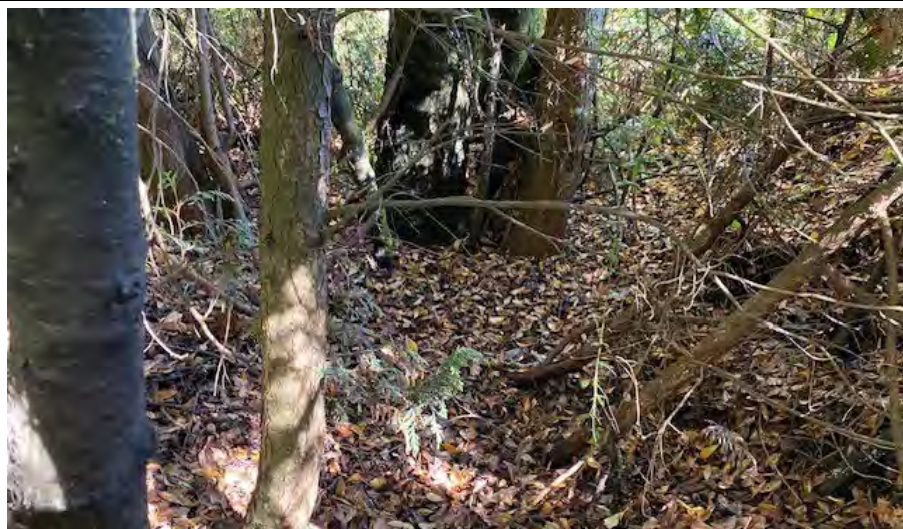
**Photo 25**-Photo Point 13 looking north along a topographic trough at the northern tip of South Segment between Stottlemeyer and Bond Roads.

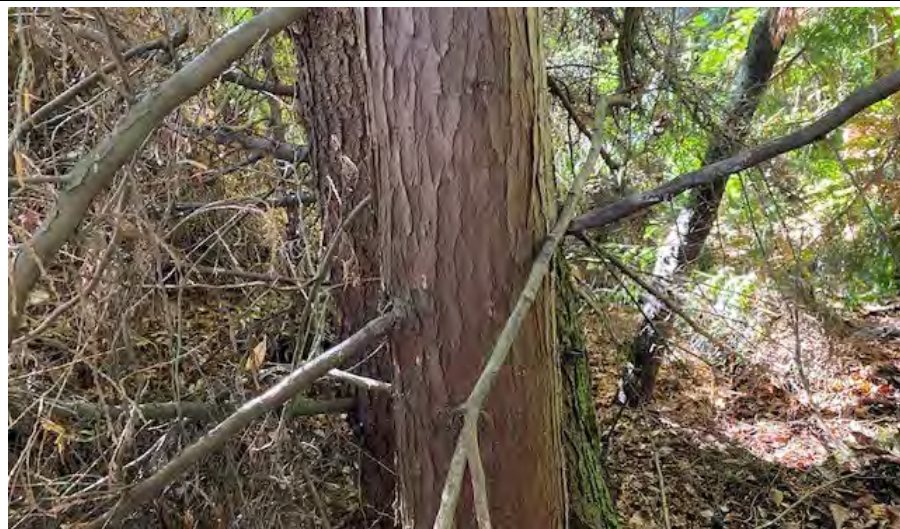
**Photo 26** Photo Point 13 looking south along the low area along Bond Road.

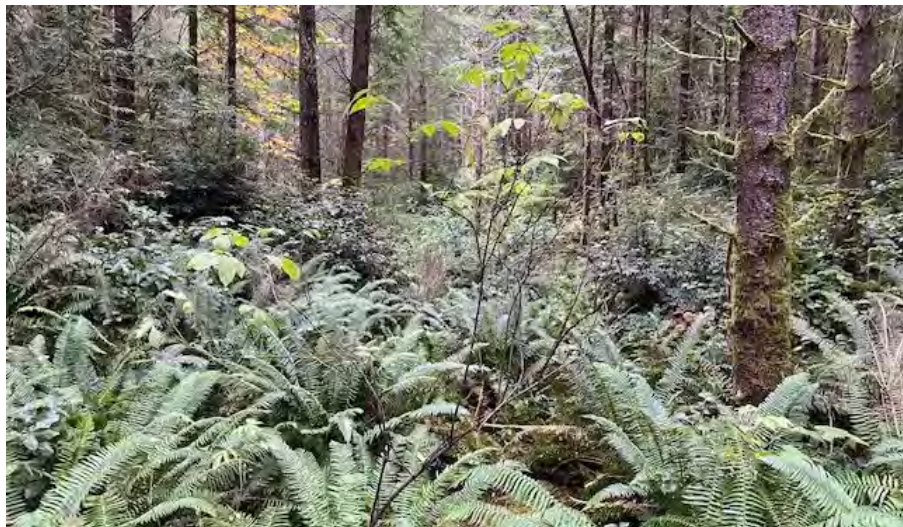
**Photo 27**-Photo Point 18 looks easterly down a topographic trough where no stream was mapped in the Central Segment.

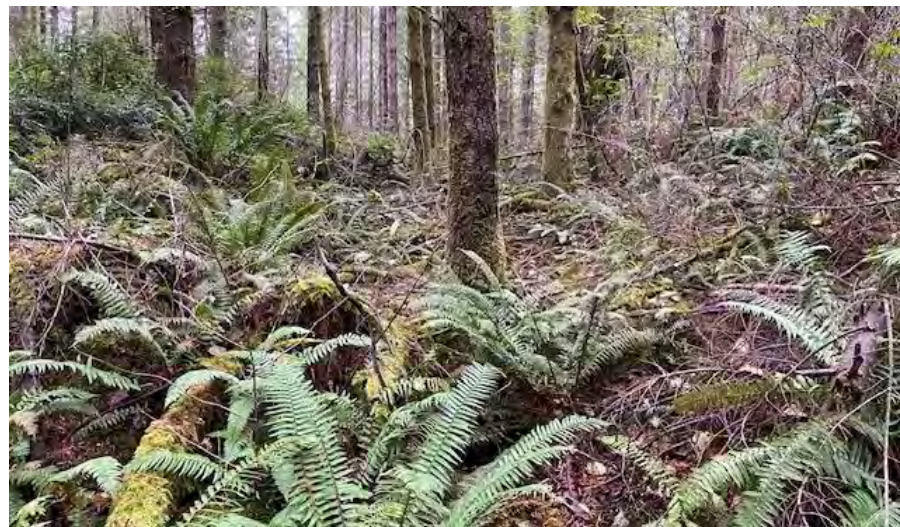
**Photo 28**-Photo Point 18 looks westerly up the topographic trough across the north end of the Central Segment. No stream observed.

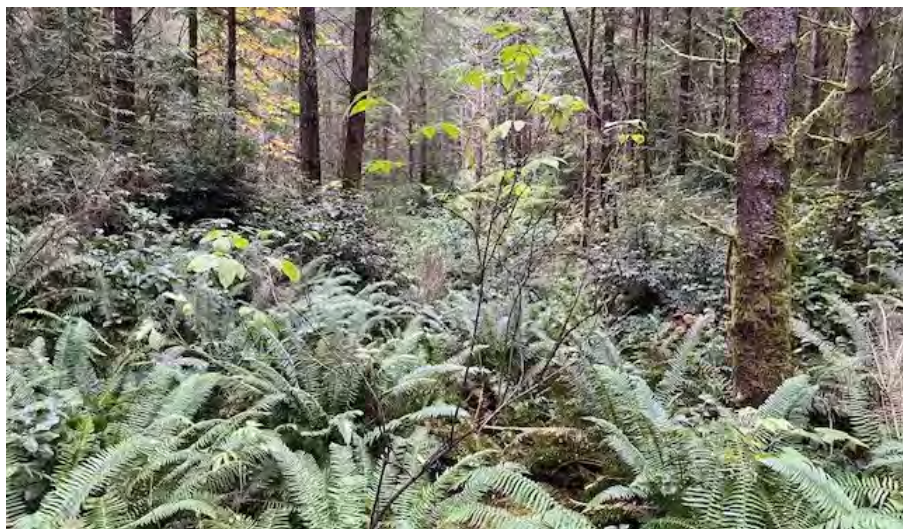
**Photo 31**-Photo Point 18 looks easterly down a topographic trough where no stream was mapped in the Central Segment.

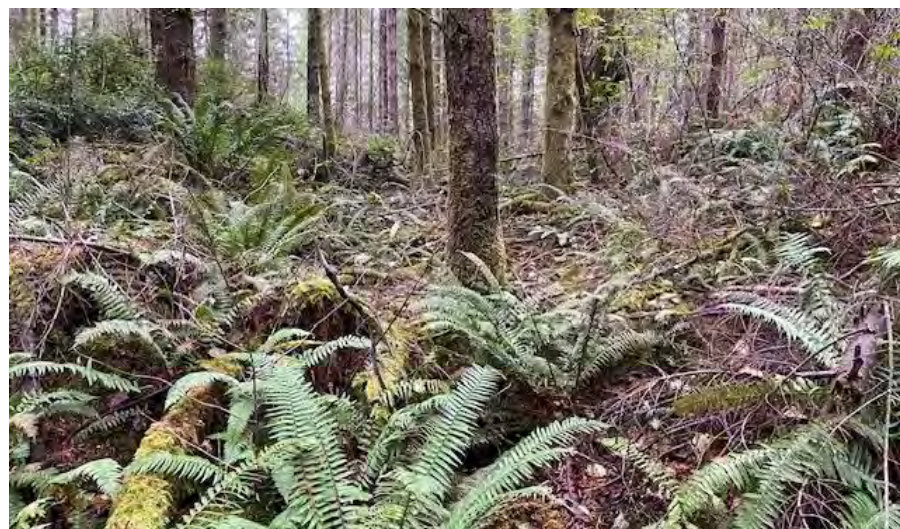
**Photo 32**-Photo Point 18 looks westerly up the topographic trough across the north end of the Central Segment. No stream observed.

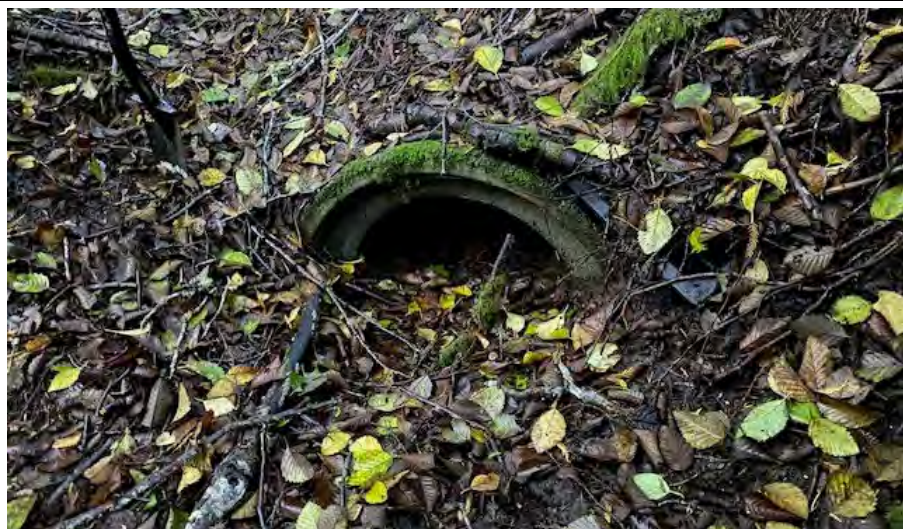
**Photo 33**-Shows the inlet of the culvert under Stottlemeyer Road, which is at the end of the non mapped stream just west of the road.

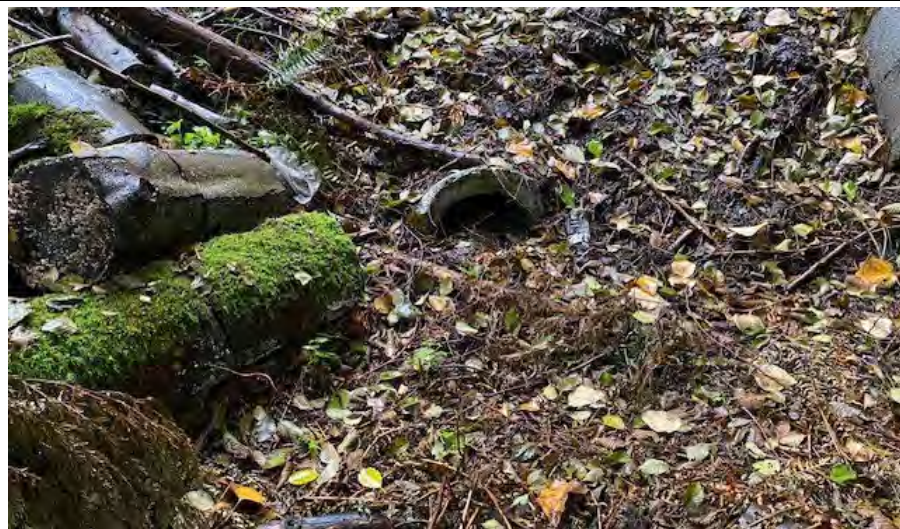
**Photo 34** shows the culvert under Bond Road in the upland between Bond and Stottlemeyer Roads in the south segment.

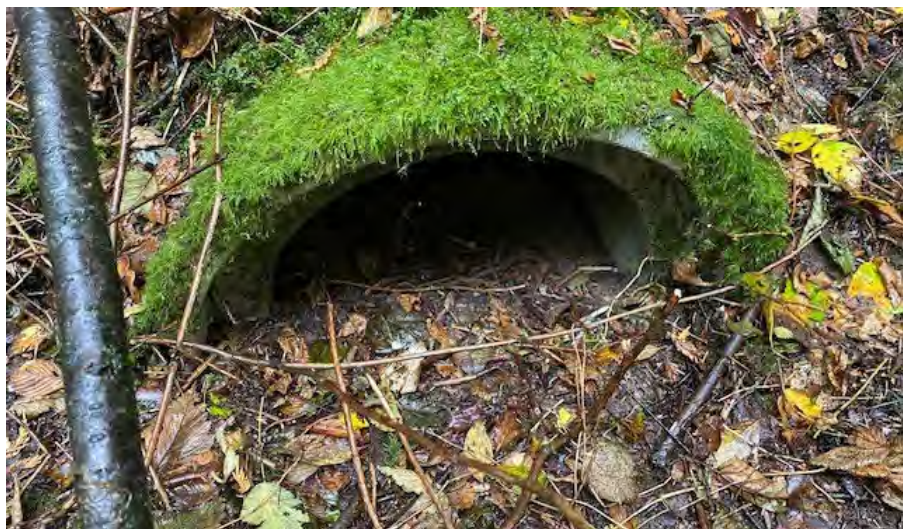
**Photo 35** shows the culvert under Bond Road at the north end of the South Segment.

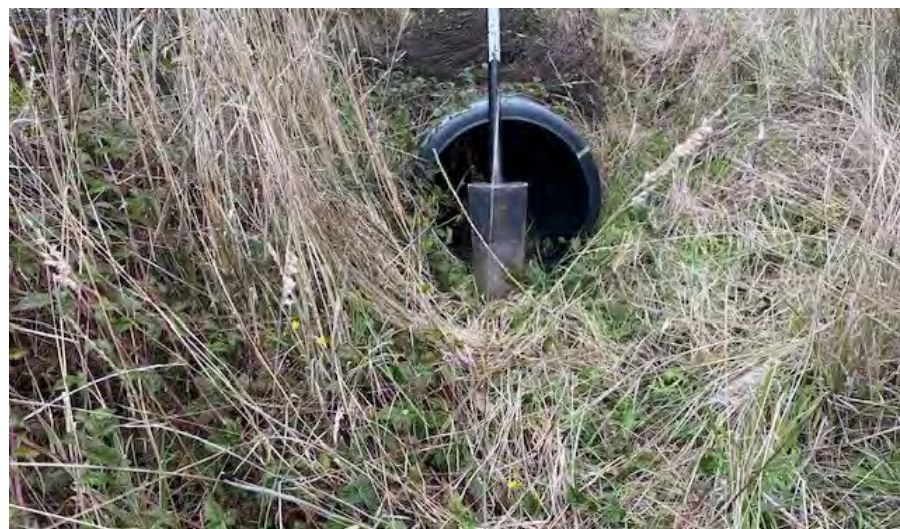
**Photo 36** shows a culvert under one of the service road. It appears that the culvert was installed during construction of logging roads.
